Learn from the mistakes of others; you'll not live long enough to make them all yourself . . . **Issue 4/2003**

Pilot Error or Poor Management?

On October 15, 2001, a Piper PA-31 departed Yellowknife, Northwest Territories, at 20:43 on a night IFR charter flight to Fort Liard. One pilot and five passengers were on board. On arrival at Fort Liard, in conditions of moderate to heavy snow, the pilot initiated a non-directional beacon (NDB) approach with a circling procedure for Runway 02. At about 22:33, the aircraft struck a gravel bar on the west shoreline of the Liard River, 1.3 NM short of the threshold of Runway 02, and 0.3 NM to the left of the runway centreline. The aircraft sustained substantial damage, but no fire ensued. Three passengers were fatally injured, and the pilot and two passengers were seriously injured. This synopsis is based on the Transportation Safety Board of Canada (TSB) Final Report A01W0261.

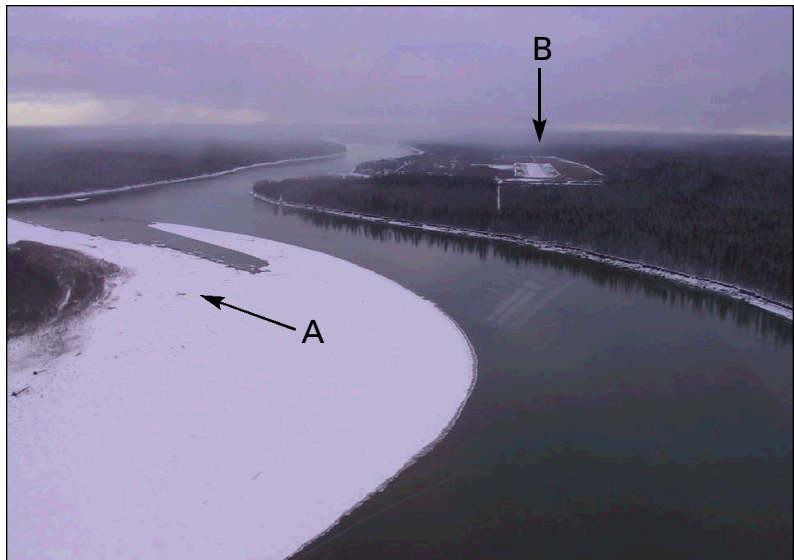
The pilot did not express any concerns and there was no warning of the impending impact. The aircraft contacted the ground in approximately a 5° nose-low and 5° to 10° left-wing low attitude, and remained upright. The impact forces did not significantly compromise the survival space in the cabin or cockpit areas. The pilot sustained severe head injuries and the right seat passenger sustained fatal head injuries due to impact forces. These injuries may have been prevented or reduced in severity had the upper torsos of these occupants been restrained by the available shoulder harnesses.

Aerial view shows wreckage at arrow A, and intended landing runway at arrow B.

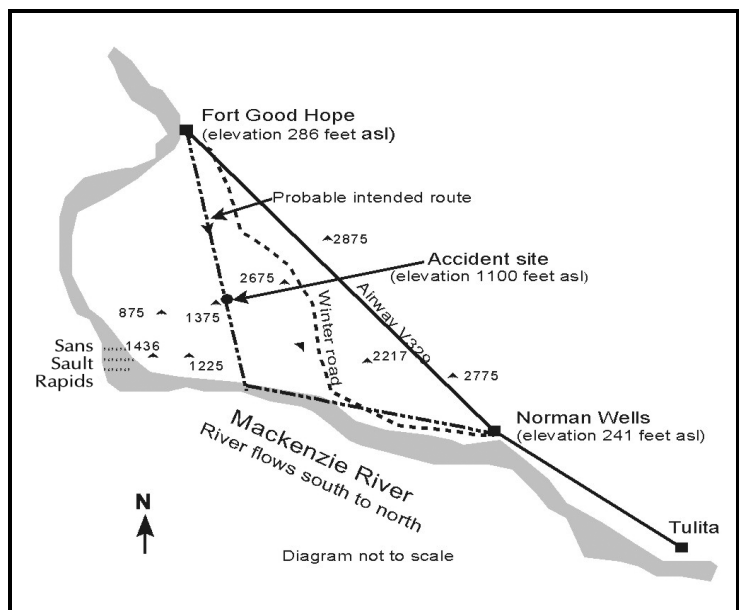
conditions. Examination of the wreckage showed that the aircraft struck the mountain in straight and level flight at low speed, and fell about 50 ft down the slope where it became entangled in trees. A layer of rime ice was evident on the wing struts.

Analysis—The location of the accident site suggests that the pilot had flown directly south from Fort Good Hope to intercept the river valley upstream of Sans Sault Rapids, bypassing the rapids. Based on the information gathered, it is probable that the pilot encountered icing conditions and reduced visibility in snow showers or cloud. Since the wreckage remained intact and three of the occupants survived the direct impact with non-life-threatening injuries, the pilot was most likely flying at low airspeed. Perhaps he was intentionally flying slow and low in an attempt to maintain or regain visual reference with the terrain. The cruise flight configuration and the straight and level aircraft attitude at impact are consistent with a CFIT accident.

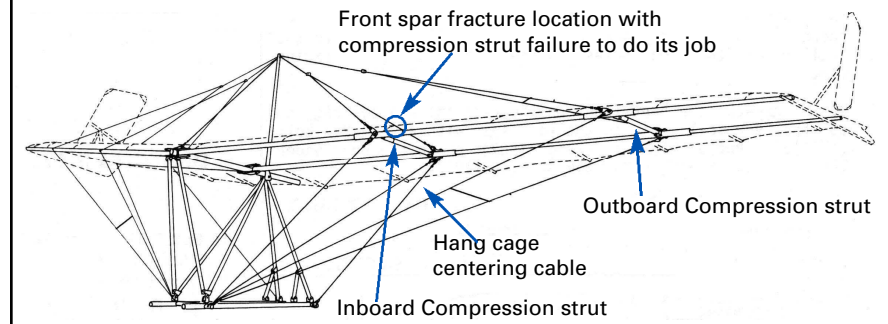
Pterodactyl Wing Spars, Struts and Rigging

The official investigations listed these accidents as “Undetermined,” but the follow-up factory investigations found the answers. In each case the spar failed just outboard of the inboard spar sleeve junction, where the inner set of rigging cables joins the spar. The spar failed upwards and twisted as it failed, giving a very distinctive signature to the failure.

These spar failures all had the same signatures and the same causes—the inboard compression strut had failed to do its job. Each wing has two compression struts. The compression struts are designed to keep the front and rear tubular spars apart and also to take the wing’s inter-spar compressional forces. Without the inboard compression strut in place, both spars will move together until one breaks. The rear spar is prevented from moving forward by the hang cage centering cable, so the front spar is the one that fails.

The key defence against these kinds of spar failures is a good pre-flight inspection. Special care should be taken to inspect these after the aircraft has been re-assembled or has undergone maintenance affecting the compression strut area.
